Re hability Of RC Homes The Use Of Structural Partitions

Abstracts:

A evolved macroscopic model is applied to the evaluation of an example structure to demonstrate the use and blessings of the version. The lateral potential of a three storeys reinforced concrete (RC) constructing earlier than and after rehabilitation become assessed the use of pushover analysis and nonlinear dynamic analysis. The nonlinear dynamic time history analysis became performed the use of El Centro document at some point of the Imperial Valley earthquake scaled to one of a kind peak ground accelerations (PGA). A rehabilitation approach the use of structural walls become designed and tested the usage of pushover analysis and nonlinear dynamic evaluation with the El Centro file as the ground motion time history input.

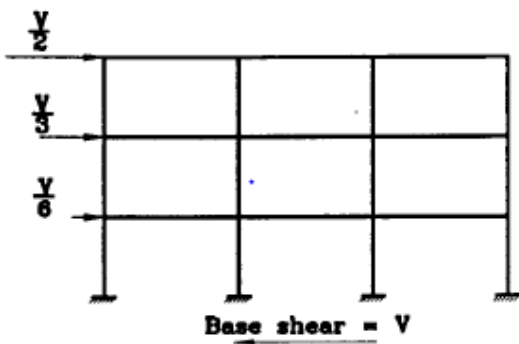
Figure 5 lateral load distribution for pushover analysis.

The purpose of the nonlinear pushover analysis was to identify the lateral strength of the structure and its behaviour under static load. The three-storey frame was subjected to an increasing monotonic lateral load of an inverted triangular distribution. The lateral load was distributed over the height of the building as shown in figure 5.

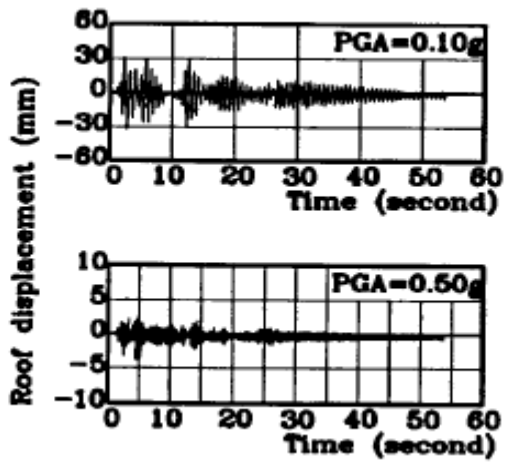
Figure 9 Roof displacement time histories for the three storey building before and after rehabilitation due to centro record.

Figure 9a shows the roof displacement time histories for the existing frame subjected to El Centro record scaled to PGA of 0.10g, 0.15g and 0.20g. When the record scaled to PGA of 0.20g is used as input ground motion, failure of the building occurred 13.02 seconds into the earthquake record. The maximum roof displacements were 32.58 mm (0.30% drift), 42.84 mm (0.40% drift) and 57.83 mm (0.54% drift) for peak ground accelerations of 0.10g, 0.15g and 0.20g, respectively.

Figure 9b shows the roof displacement time histories for the rehabilitated frame when subjected to the El Centro record scaled to PGA of 0.50g, 0.70g and 0.75g. When the record scaled to PGA of 0.75g is used as input ground motion, failure of the building occurred 0.301 seconds into the earthquake record. The maximum roof displacements were 3.61 mm (0.03% drift), 5.08 mm (0.05% drift) and 22.15 mm (0.21% drift) for peak ground accelerations 0.50g, 0.70g and 0.75g, respectively.

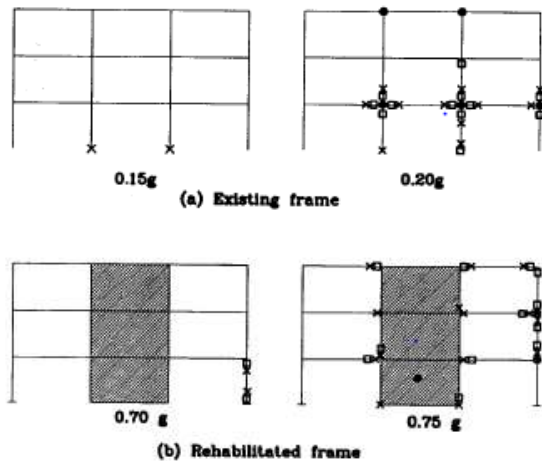
- Concrete softening.
- * Bond slip softening
- Shear failure in a beam-column joint or in a RC wall.

Figure 12 Damage to the three storey building due to EI centro record scaled to the shown values.

Figure 12a shows the damage to the building when subjected to the ground motion record. For peak ground acceleration up to 0.10g, there was no damage. Some of the elements yielded but none of them reached the strength degradation part. According to this definition, the building is still in the repairable phase and damage is minor. For the case of PGA of 0.15g, bond slip failure occurred at the base of the two interior columns. The damage at this stage will be more difficult to repair. For peak ground acceleration of 0.20g, extensive damage and collapse of the building occurred before the completion of the earthquake record. It is observed that beam-column joint shear failure occurred in five of the joints. That is different from the case of pushover analysis where there was no identified beam-column joint shear failure. This is due to the fact that the shear rigidities of the joints have significantly deteriorated due to the cyclic load application. A behaviour which can not be captured by the pushover analysis. This deterioration combined with deterioration in steel and concrete elements due to the cyclic behaviour resulted in the limited ductility that appeared in the dynamic analysis.

Figure 12b shows the damage occurred after the completion of the earthquake record. For peak ground acceleration up to 0.50g, there was no damage. Some of the elements yielded but none of them reached the strength degradation part. This means that the building is still in the repairable phase. Considering peak ground acceleration of 0.70g, bond slip failure and concrete crushing occurred in the external columns. The damage at this stage will be more difficult to repair. For peak ground acceleration of 0.75g, collapse of the building occurred before the completion of the earthquake record and as can be seen in figure 12b, major damage was detected. It is noticeable that beam-column joint shear failure occurred in two of the joints and shear failure occurred in the first story of the shear wall. That is different than the results from the pushover analysis where there was no shear failure.
