The Relationship Between Structural Divisions And The Health Of RC Homes

N.KRANTHI KUMAR, P MOUNIKA
Department of Civil Engineering,
Email Id: nnk.pallaviec@gmail.com, mounikapeerla73@gmail.com
Pallavi Engineering College,
Kuntloor(V),Hayathnagar(M),Hyderabad,R.R.Dist.-501505

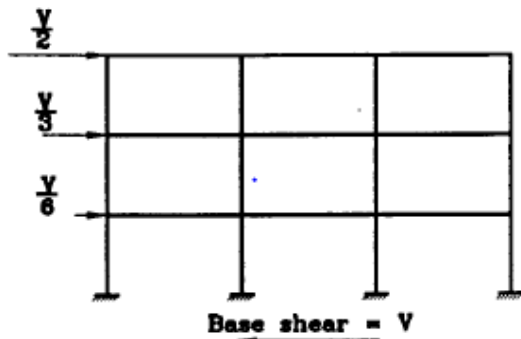
Figure 5 lateral load distribution for pushover analysis.

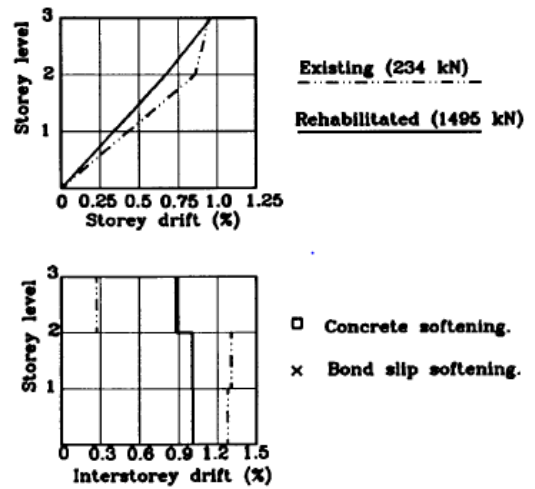
Figure 7 Storey drift and interstorey drift due to pushover analysis

Figures 7 shows the distribution of storey drifts and interstorey drifts along the height of the building for both the existing and rehabilitated frames. For the existing frame, the interstorey drift in the first two floors is much higher than the third floor. This means that damage is mainly concentrated in the first two floors. For the rehabilitated frame, the interstorey drift in the three floors is nearly equal which implies that the rehabilitation system is effective in distributing the damage along the building height.

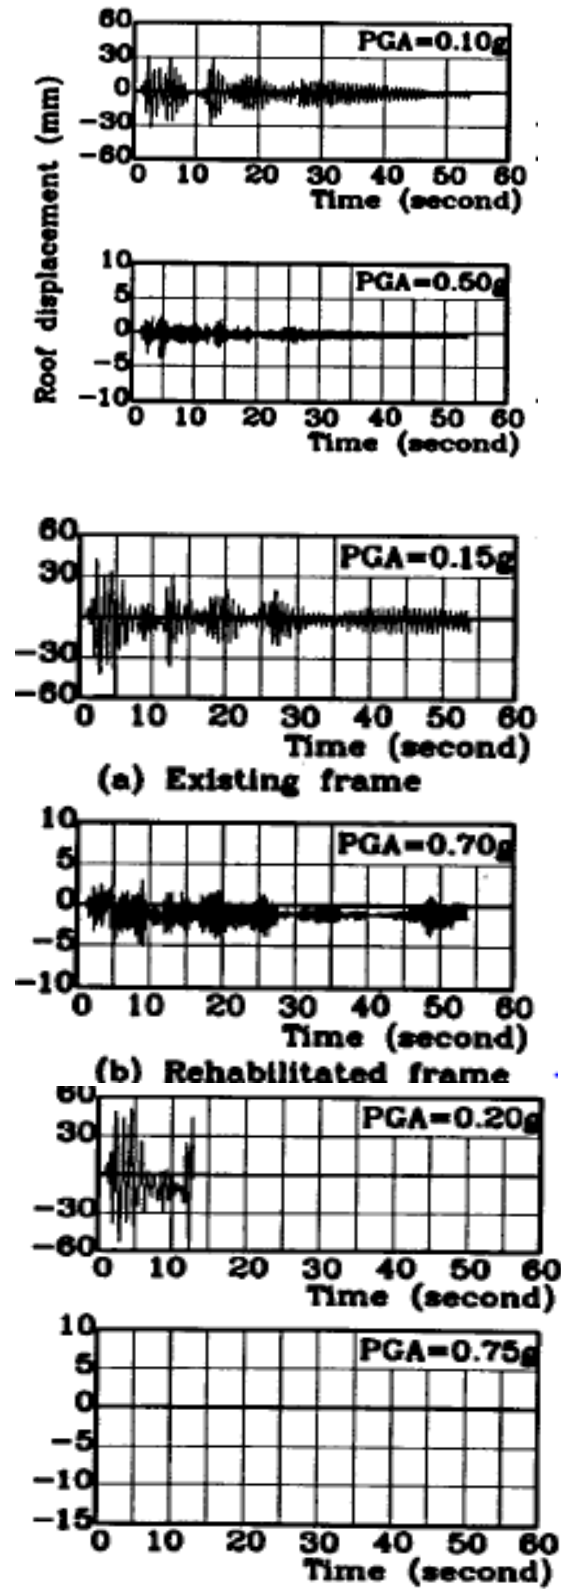
Figure 9 Roof displacement time histories for the three storey building before and after rehabilitation due to centro record.

Figure 9a shows the roof displacement time histories for the existing frame subjected to El Centro record scaled to PGA of 0.10g, 0.15g and 0.20g. When the record scaled to PGA of 0.20g is used as input ground motion, failure of the building occurred 13.02 seconds into the earthquake record. The maximum roof displacements were 32.58 mm (0.30% drift), 42.84 mm (0.40% drift) and 57.83 mm (0.54% drift) for peak ground accelerations of 0.10g, 0.15g and 0.20g, respectively.

Figures 9b shows the roof displacement time histories for the rehabilitated frame when subjected to the El Centro record scaled to PGA of 0.50g, 0.70g and 0.75g. When the record scaled to PGA
